Restauration du Patrimoine — Maçonnerie

Taille de pierre — Matériaux nobles et naturels

General contractor :
Commune de Brantôme

Full renovation of the old church Notre-Dame of Brantôme Registered MH 1958

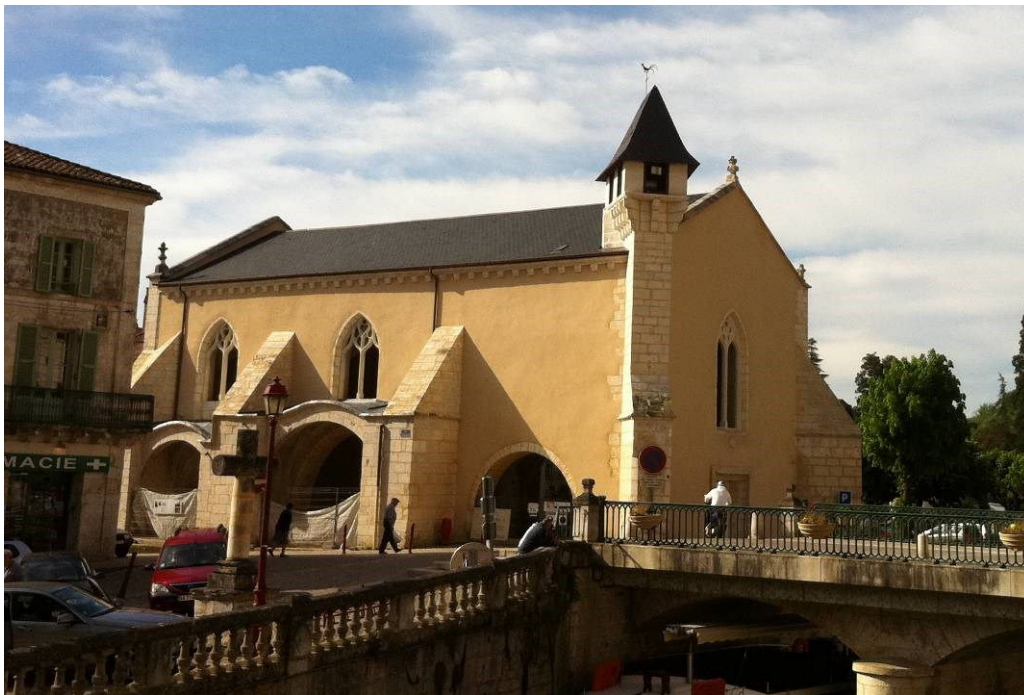
General view

Church originally created in the XVIth century and transformed into a covered marketplace in the XIXth century.

Building registered as Historical Monument since 1958

The latest use of the place was dedicated to sport activities

The renovation consisted in reconstituting of the indoors and outdoors spaces to re-create its original aspect
